Why Do Small Earth Dams Deteriorate: Insights from Physical Investigations in the West African Sahel

Keywords: degradation; detailed technical visit; laterite; Sahel; small earth dam

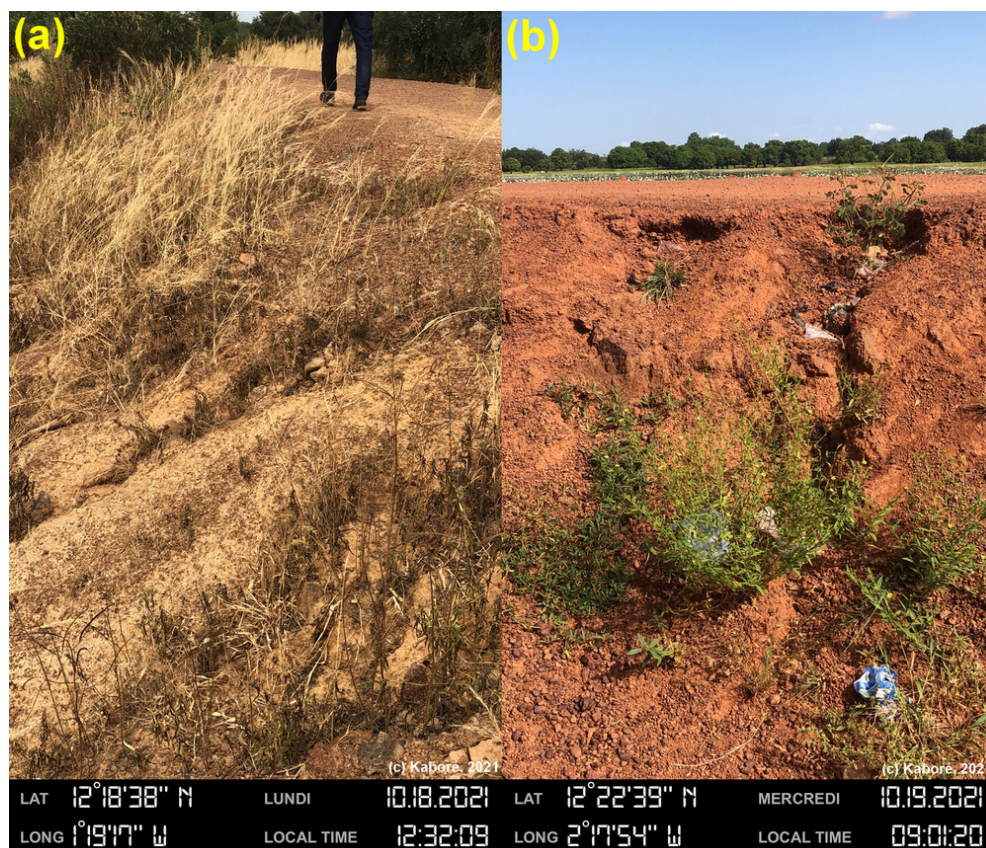
Figures 4–13 illustrate the degradation observed on the various sites visited. A pronounced aspect of surface erosion has been noted, with a significant presence of gullies on the irregular slopes (Figure 4a,b), accounting for slightly more than 87% of the structures visited. These gullies manifest as channels that deepen in the direction of the slope. Observations suggest that they are due to the concentration of runoff water, which can transform the dyke downstream facing into a “ploughed field” [18,25,56], thereby compromising its safety [57]. According to [25], this phenomenon is relatively common on unprotected slopes (often opted as a cost-saving measure) or those irregularly covered by vegetation, rendering the structure susceptible to erosion risk due to runoff.

Figure 4. (a) Gully on a downstream slope, *Petit Tansobentenga* dam (Centre Region). (b) Gully on a downstream slope, *Godin-Oudalogtinga* dam (Centre-West Region).

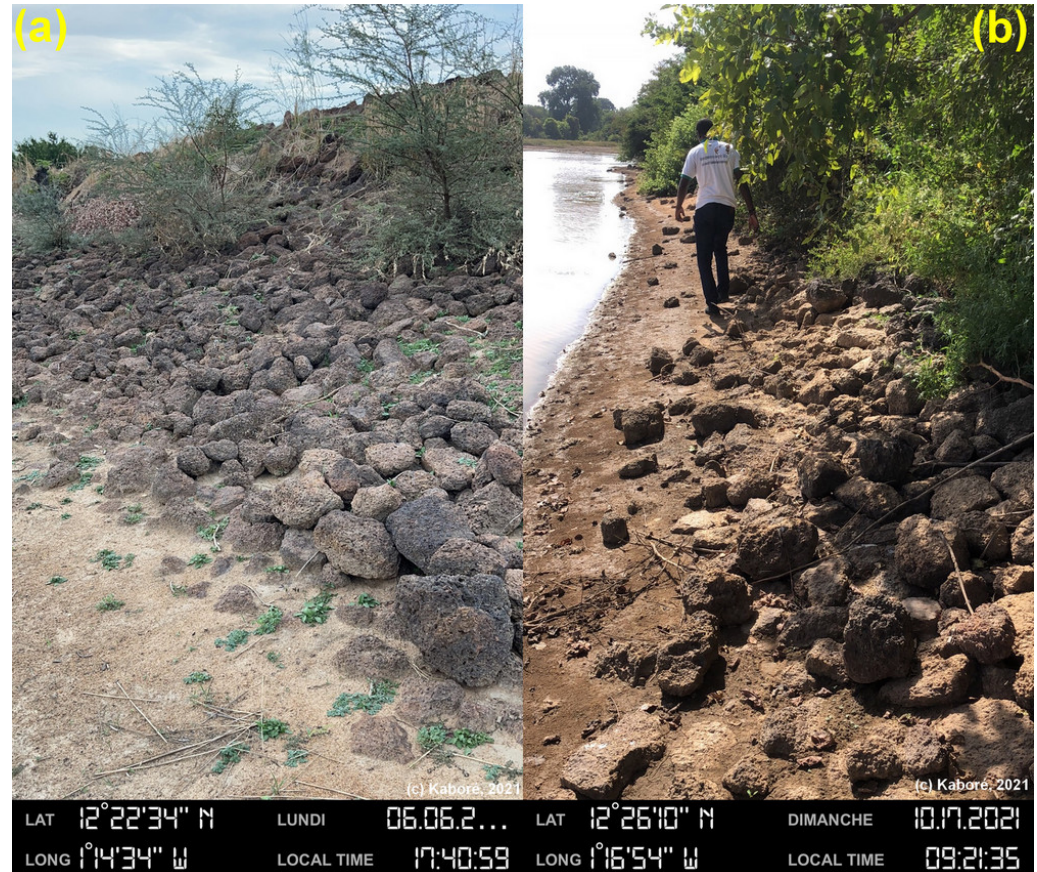
Additionally, disorders characterized by degradation of the upstream banks, including those with riprap protection, were observed (Figure 5a,b) along the entire length of

the dike on nearly 92% of the selected structures. These disorders are likely attributable to the effects of wave action generally caused by wind. The energy of the waves breaking on the riprap allows water to penetrate, enabling reflux movements to damage the revetment by displacing or carrying away the riprap blocks.

Figure 5. (a) Disorders on upstream riprap, *Koala* dam (Centre Region). (b) Disorder on upstream riprap, *Siga* dam (Centre Region).

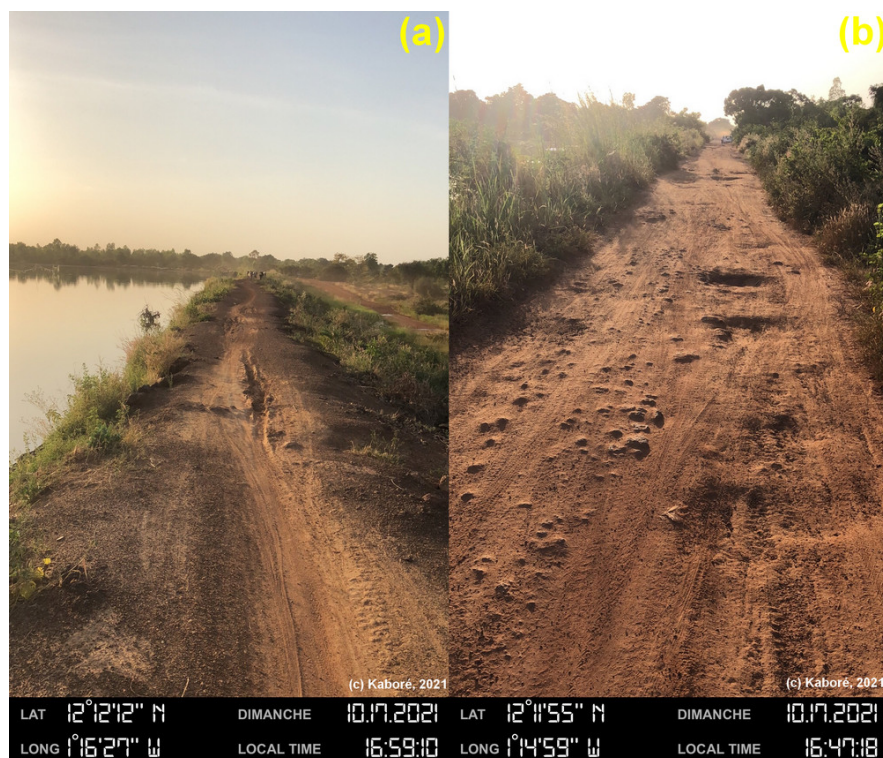
Subsidence and trampling, typical of anthropogenic erosion, were also observed, as indicated in Figure 6a,b. The evolving nature of the construction material, combined with the effects of routine vehicle overloading (which is common practice in the context), accelerates the degradation of the platforms. The trampling phenomenon is particularly significant when the constituent material of the dike has low cohesion [58]. The presence of a cohesive material on these dikes slows this type of erosion but requires regular monitoring, which is virtually non-existent in Burkina Faso.

Figure 6. (a) Anthropogenic erosion of the platform, *Ramogwende* dam (Centre Region). (b) Anthropogenic erosion of the platform (due to vehicle passage), *Ridrin* dam (Centre Region).

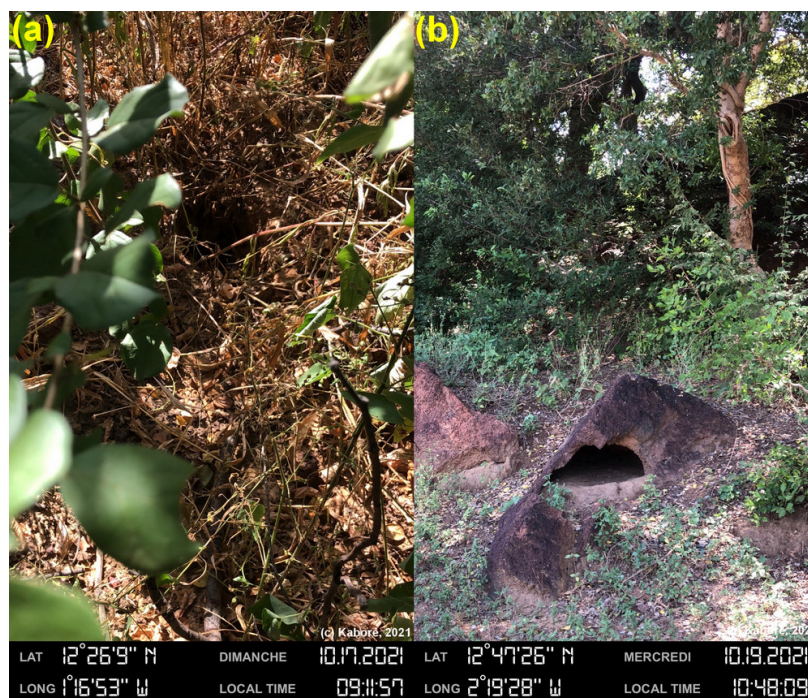
Burrows manifesting as gaping holes in the embankment caused by the presence of burrowing animals such as rodents or crocodiles (Figure 7a,b) were also noted on a few structures, accounting for only 8% of the dikes in our sample. The trampling phenomenon is particularly significant when the constituent material of the dike has low cohesion [58]. The presence of a cohesive material on these dikes slows this type of erosion but requires regular monitoring.

Figure 7. (a) Presence of burrows on the dam due to rodents, *Siga* dam (Centre Region). (b) Presence of burrows due to digging crocodiles, *Veh* dam (Northern Region).

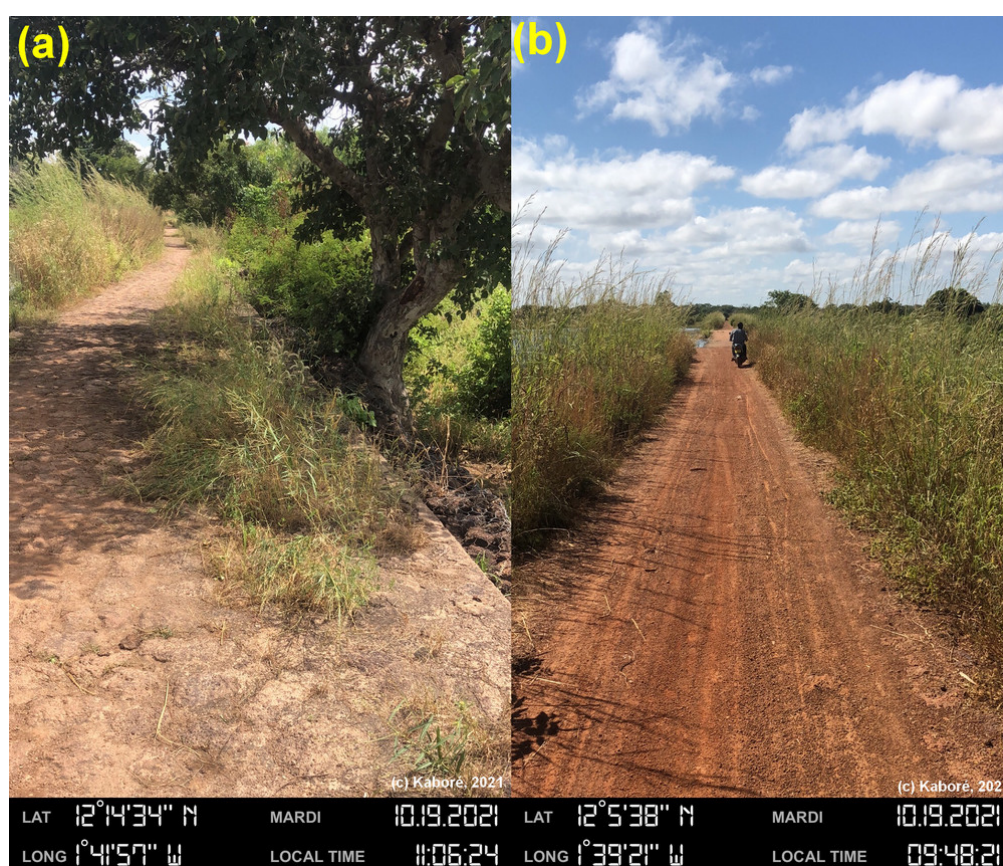
Large-scale vegetation growth was also observed on the sites, as illustrated in Figure 8a,b. Given the extent of this phenomenon, it is important to note the critical lack of maintenance these structures face. According to [59,60], who addressed the issue of vegetation growth on French river dikes and small earth dams via the development and decomposition of root systems, the presence of woody plant species poses physical and integrity safety concerns [61]. Trees and shrubs obstruct visual surveillance of the structures and also promote the presence of burrowing animals that dig burrows in the embankments, as previously shown in Figure 7a. [62] emphasizes that the development and decay of root systems are factors that weaken dikes in the short and medium term. Our DTVs revealed that 100% of our dikes are affected by vegetation growth. To highlight a potential cause-and-effect relationship between vegetation growth and erosion, it is suggested that the development of woody root systems within our dikes generates risks of degradation and erosion related to the action of living roots and the phenomenon of wood decomposition [59].

Figure 8. (a) Vegetation on dam and spillway, *Koakin* dam (Centre Region). (b) Vegetation on upstream and downstream slopes, *Kalzi* dam (Centre Region).

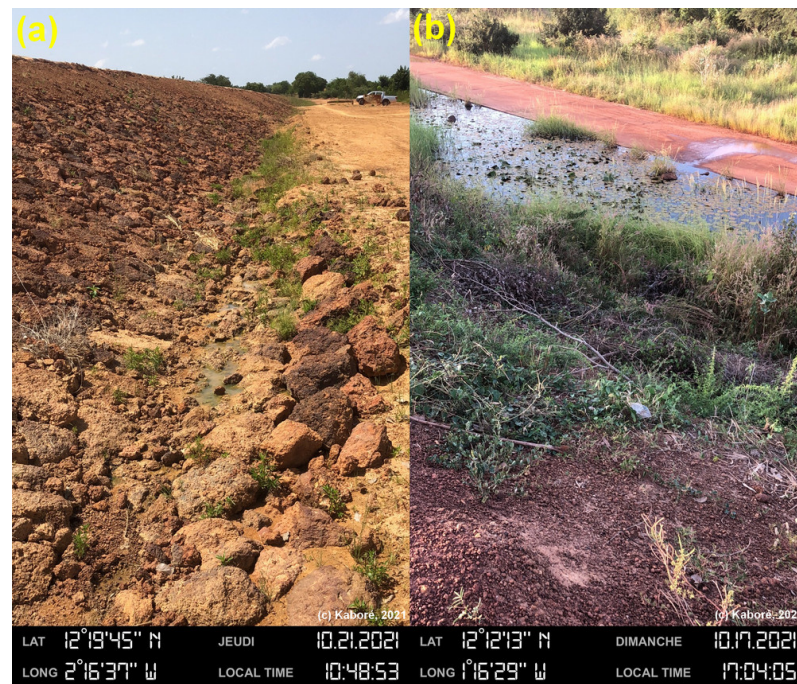
Additionally, it should be noted that trees uprooted by wind can cause visible damage, while decomposed roots leave unperceivable galleries within the embankments through which water can find passage [59]. Of the dikes that are part of our field study, 50% also show water leakage from upstream to downstream at the base of the slope, as indicated in Figure 9a,b.

Figure 9. (a) Presence of slight leak in the upstream-downstream direction, *Doulou* dam (Centre-West Region). (b) Presence of slight leak in the upstream-downstream direction, *Ramogwende* dam (Centre region).

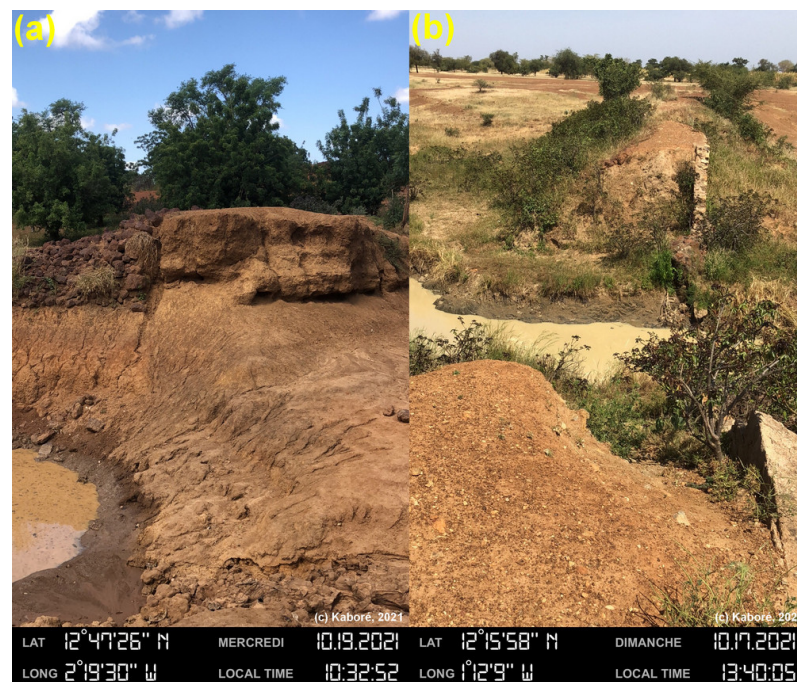
Among the other disorders observed, transverse cracks in the embankment dike, as illustrated in Figure 10a,b, were noted, particularly in zones of rupture or near-rupture. Their potential causes include differential settlement leading to fractures in the structures or internal erosion revealing water passage within the embankment body. These transverse cracks, however, could also be attributed to a lack of comprehensive technical studies before execution, which would ensure better consideration of the force of floodwaters the structure must withstand [22,25].

Figure 10. (a) Transverse cracking, *Salouf Boulssi* dam (Centre Region). (b) Transverse cracking, *Veh* dam (Northern Region).

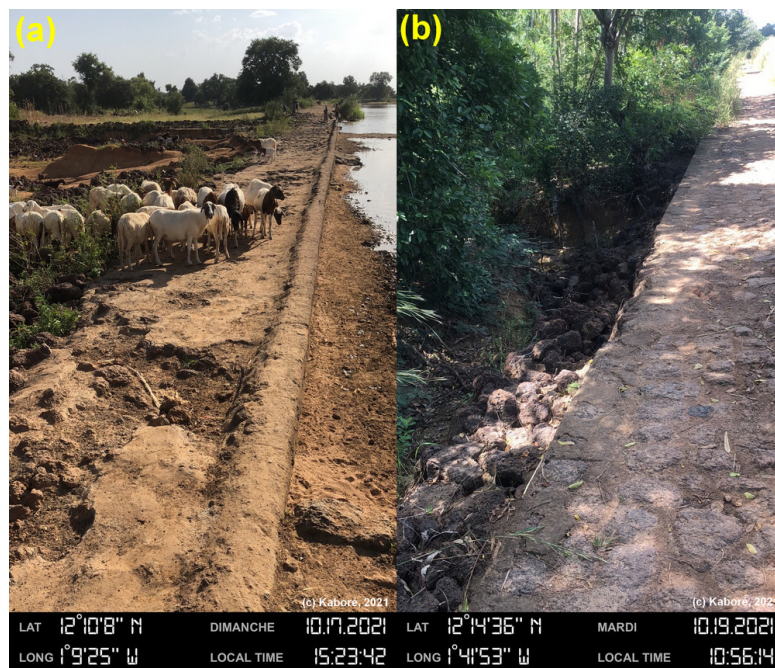
The destruction of the stilling basin and the evacuation channel, as shown in Figure 11a,b, representing the *Tansablogo II* dam (Centre Region), perfectly illustrates the poor dimensioning of the spillway and its components. The consideration of hydraulic jumps emerging in the dissipation basin was largely underestimated or minimized for most of these structures, as suggested in [63]. Nearly 75% of our structures exhibited such type of degradation.

Figure 11. (a) Destroyed dissipation basin and eroded evacuation channel, *Tansablogo II* dam. (b) Destroyed gabion cage and dissipation basin, eroded evacuation channel, *Koakin* dam (Centre Region).

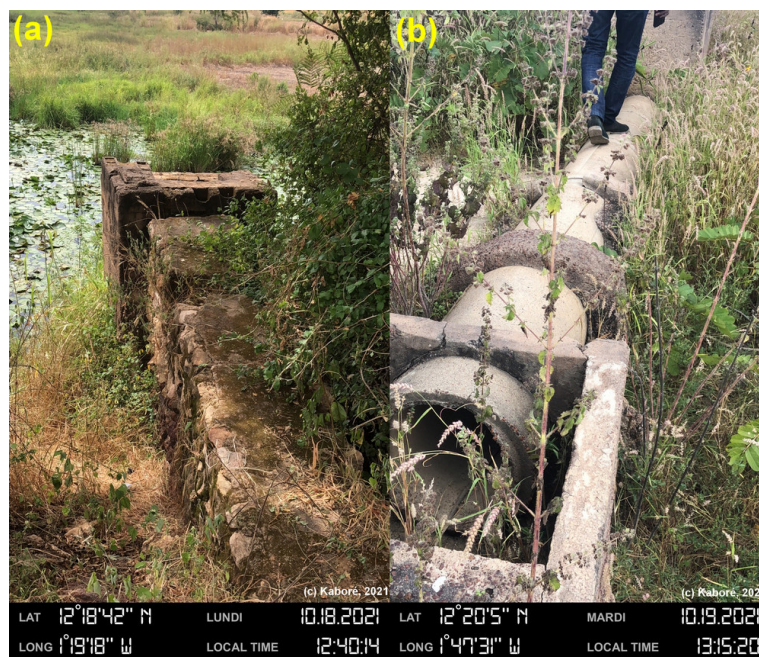
The stilling basins in place are primarily made up of concrete, with a notable lack of maintenance observed in many of these structures, including ancillary structures such as water intakes (Figure 12a,b).

Figure 12. (a) Aging intake structure, *Petit Tansobentenga* dam (Centre Region). (b) Aging intake structure, *Taama* dam (Centre Region).

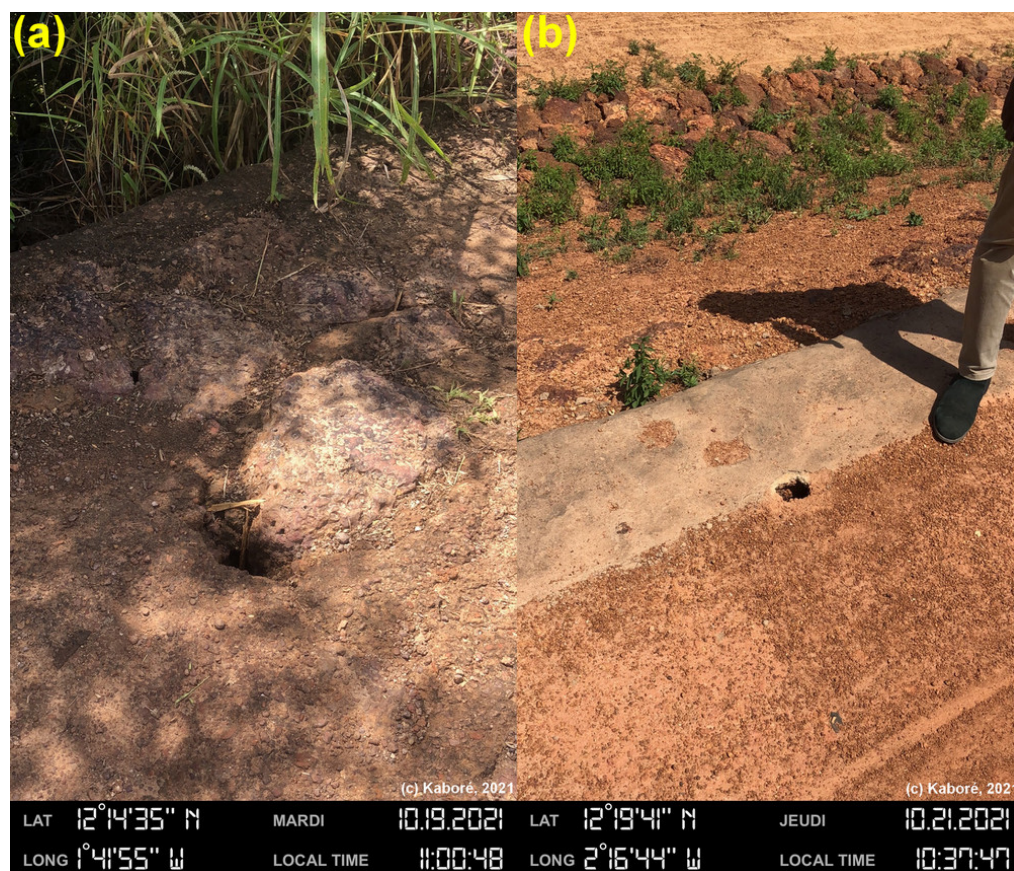
It is also worth noting that the presence of internal erosion on the crest is the source of infiltration into the embankments [30,64–70], as shown in Figure 13a,b.

Figure 13. (a) Orifice on crest causing internal erosion, Doulou dam (Centre-West Region). (b) Orifice on crest spillway causing internal erosion, Koakin dam (Centre Region).
