Why Do Small Earth Dams Deteriorate: Insights from Physical Investigations in the West African Sahel

Keywords: degradation; detailed technical visit; laterite; Sahel; small earth dam

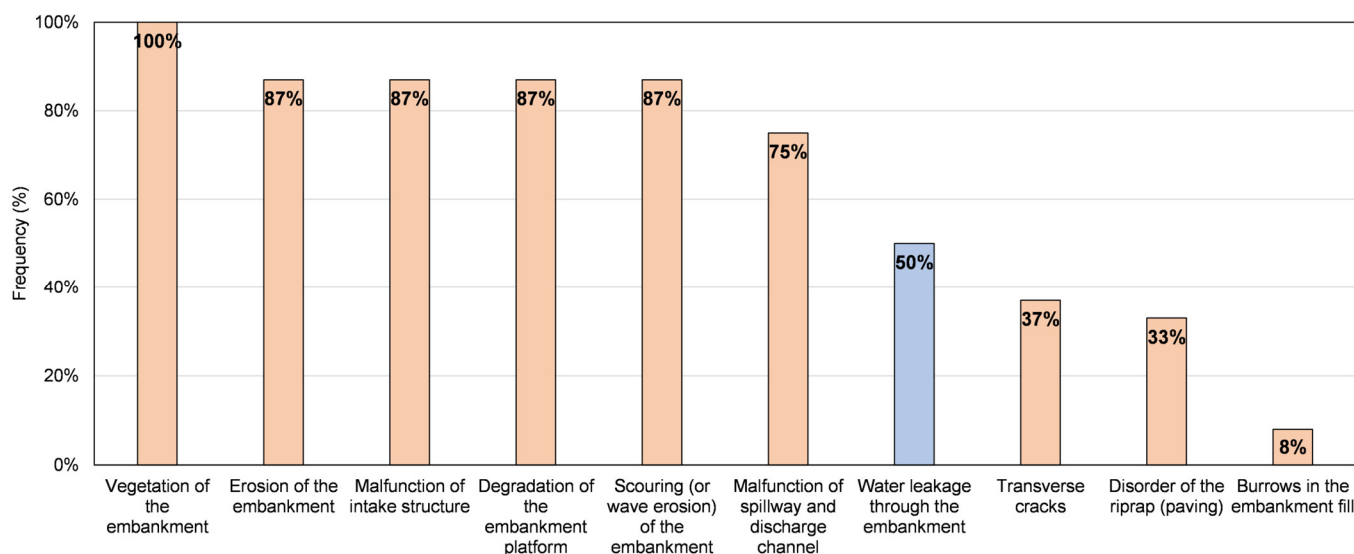
Figure 14. Frequencies of occurrence of degradation types observed on the 24 dams inspected in this study. Orange bars refer to dam embankment superficial degradations, while the blue bar refers to dam embankment internal degradation.

It appears that 100% of the visited dams show signs of riparian vegetation growing on the embankment fill, mainly due to poor maintenance. Signs of erosion of the embankment are observed on 87% of the dams, along with cases of degradation observed on the embankment platform (87%), scouring of wave erosion (87%), and malfunction of the intake structure (87%). These disorders are followed by malfunction of the spillway and discharge channel downstream (75%), leakage through the dam body (50%), transverse cracks (37%), disorders of the riprap paving (33%), and finally, burrows in the embankment fill (8%).
